## Section 4-2

### Replace Power Steering Cooler Hoses

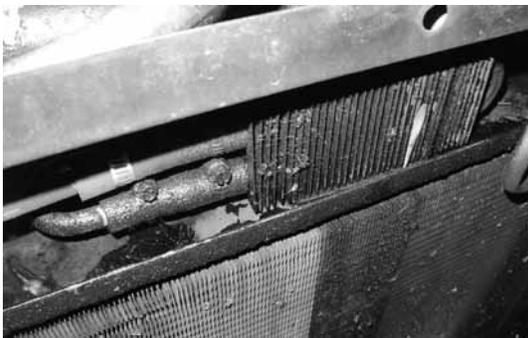
This is an easy fix for a common issue: red automatic transmission fluid dripping from underneath the radiator. You might think it to be the transmission cooler at first, but more often than not, it's the power steering cooler hoses.

Figure 4-2-1 – Radiator support drowning in fluid.

As you can see in fig. 4-2-1, the radiator support underneath the power steering cooler can completely fill with fluid. Access to the unit is improved if the deflector panel

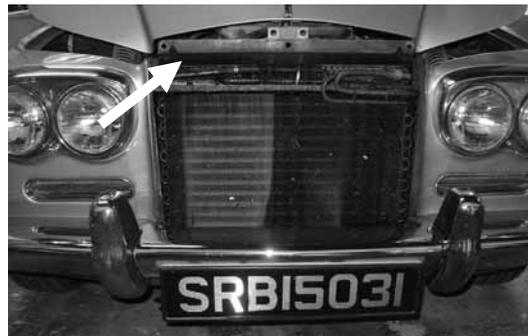
Figure 4-2-2 – Access improves with the deflector panel out.

on top of the radiator is removed. (See fig. 4-2-2.) The remainder of the procedure is simple. Remove the bolts securing the cooler, loosen the hose clamps and pull off the cooler and hose pieces being careful not to spill ATF all over the place.

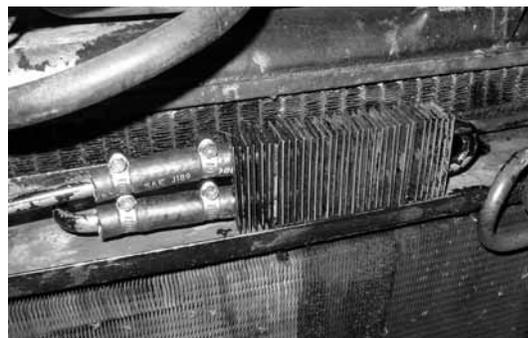
Figure 4-2-3 – New hoses and hose clamps in place.

After cleaning the cooler and surrounding area, cut two new hoses to match the old ones. Reassemble the cooler using the new hoses and hose clamps. Position the hose clamp screw heads facing

forward to allow future tightening without the need for grille removal (See fig. 4-2-3.)
